737 GRAPHITE COMPOSITE FLIGHT SPOILER FLIGHT SERVICE EVALUATION

FIRST ANNUAL REPORT
JULY 1973 THROUGH MARCH 1975

Prepared under contract NAS1-11668 by
BOEING COMMERCIAL AIRPLANE COMPANY
P.O. Box 3707
Seattle, Washington 98124

May 1975

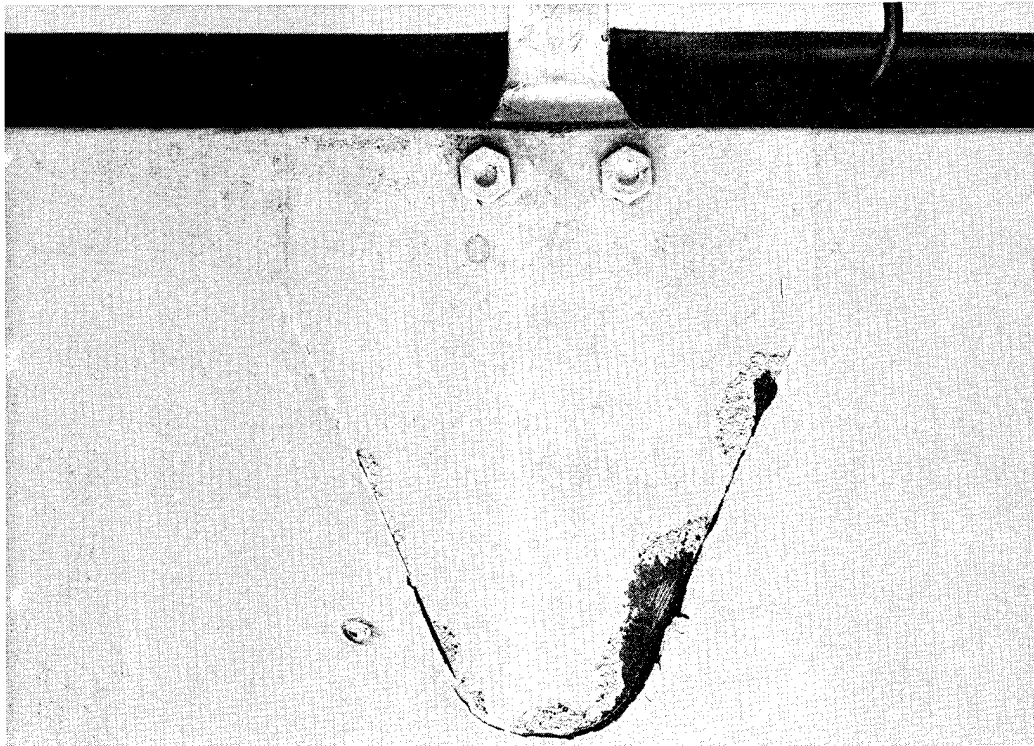
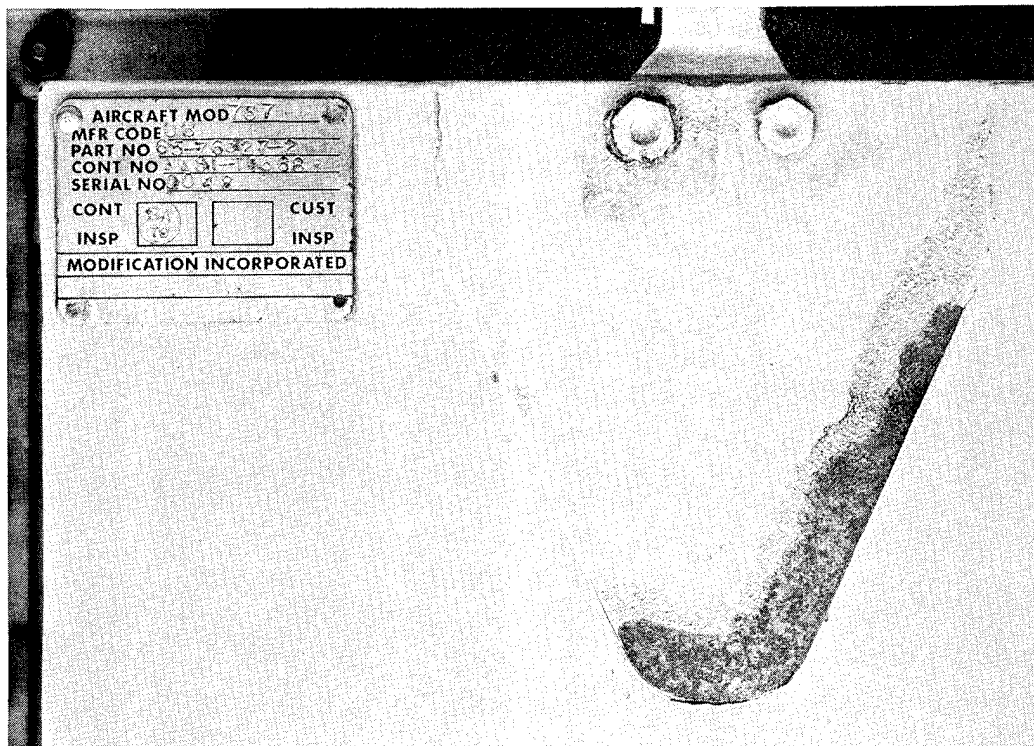
Figure 6.—Corrosion on -23 Doubler

the laminates points out very clearly that extreme caution must be exercised to avoid undesired forced displacements of the laminates. No evidence of corrosion or deterioration of the skin laminates has been observed. One case of corrosion of the aluminum bearing doublers on the spoiler lower skin was observed (spoiler S/N 0048, fig. 6). Investigation of this condition is continuing.

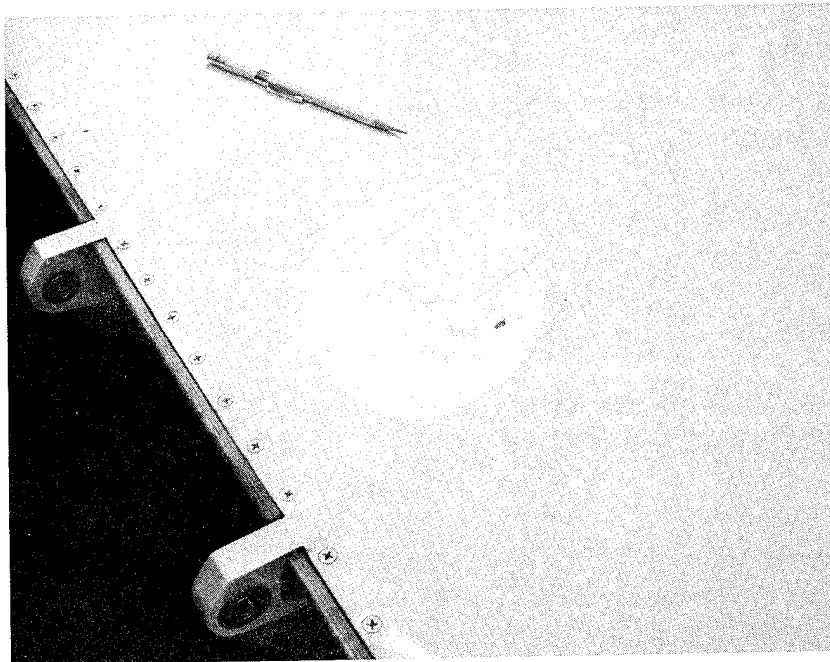
Figure 7.--Upper Surface Repair Delamination on S/N 0014

Five spoilers were selected at random for removal following the first year of service. Visual inspection of these units showed no detectable defects and only the oil and dirt associated with trailing edge components, except for spoilers S/N 0014 and 0104. Spoiler S/N 0014 showed evidence of delamination of a repair on the upper surface skin above the center hinge fitting (fig. 7). Spoiler S/N 0104 showed an upper surface skin blister, approximately 3 cm (1.2 in.) in diameter, above the center hinge fitting (CHF), which was not repaired prior to its destruction in static test.

All five spoilers were reexamined by ultrasonic testing techniques in the same manner as was employed in the original fabrication process. Comparisons between the two sets of ultrasonic recordings showed no detectable internal defects or disbonds and confirmed the external defects on S/N 0014 and 0104 which were visually noted.

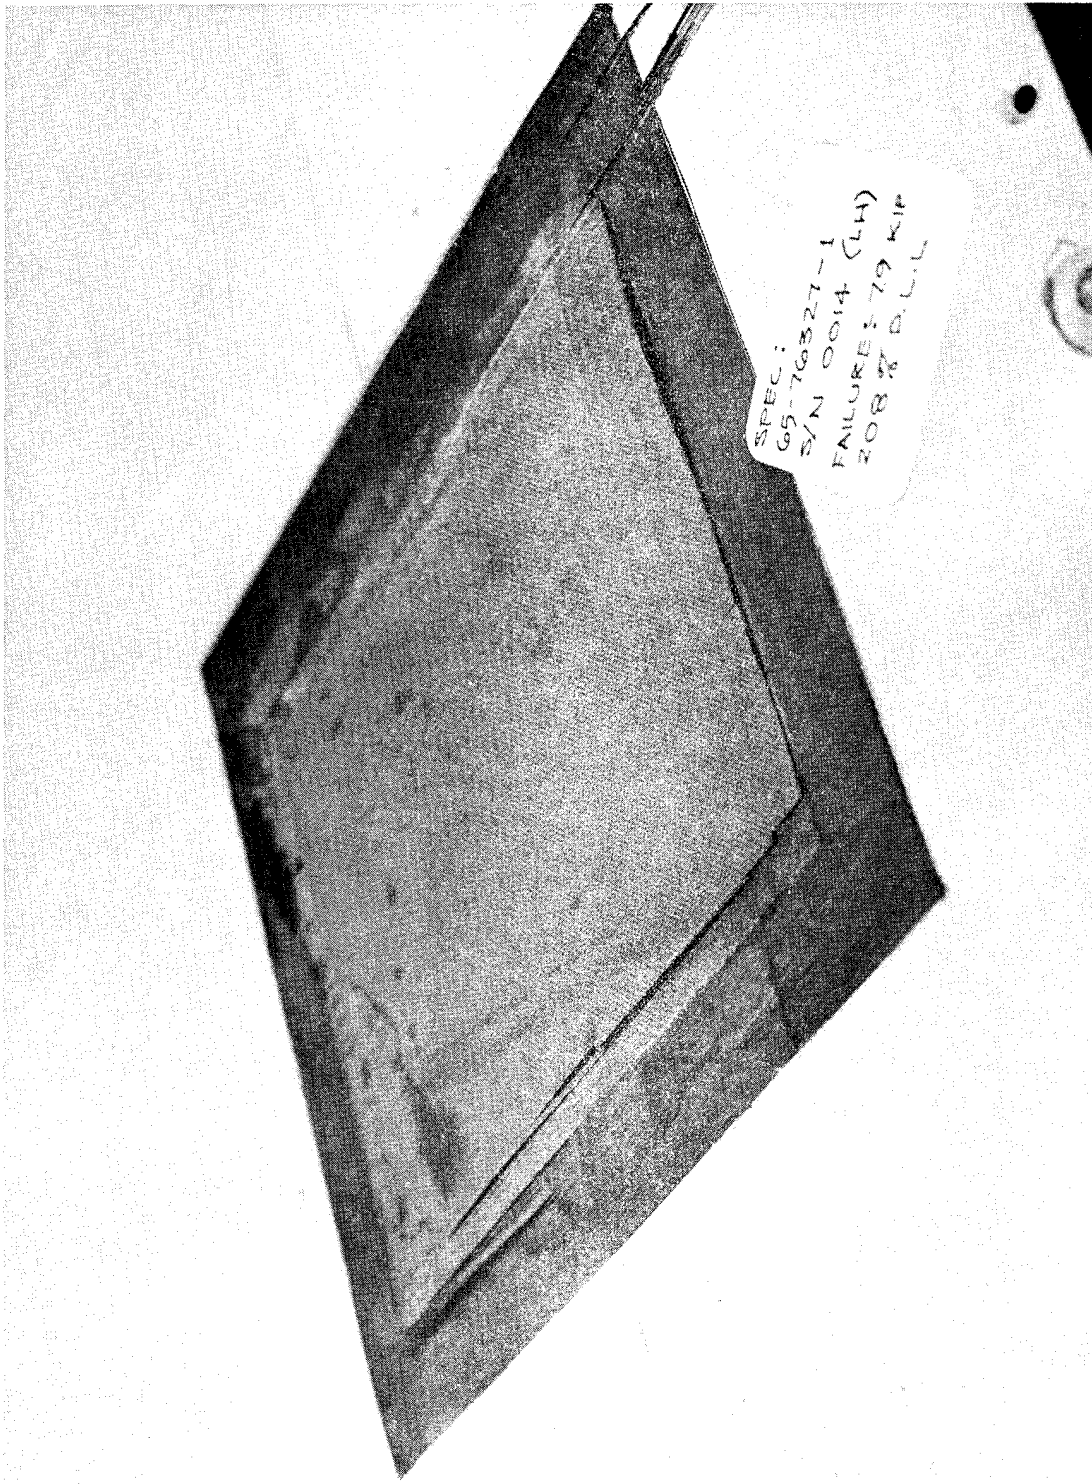
Figure 11.—Failure of S/N 0014 Through Repair

1. Initial failure of S/N 0014 was brought about by the combination of shearing of the -11 aluminum doubler above the CHF and failure of the repair patch on the upper skin above the CHF. The failure load achieved was attained despite a "resin only" joint around the edges of the repair. Repair procedures have been modified to include EA 9628 adhesive in the repair lap joints. Although the failure occurred in the skin repair area, the percentage loss in failure load was essentially no greater than for the other two test specimens. Failure of the comparable certification test spoiler (S/N 0002) was attributable to lower surface skin buckling near the CHF due to deflection of the CHF.

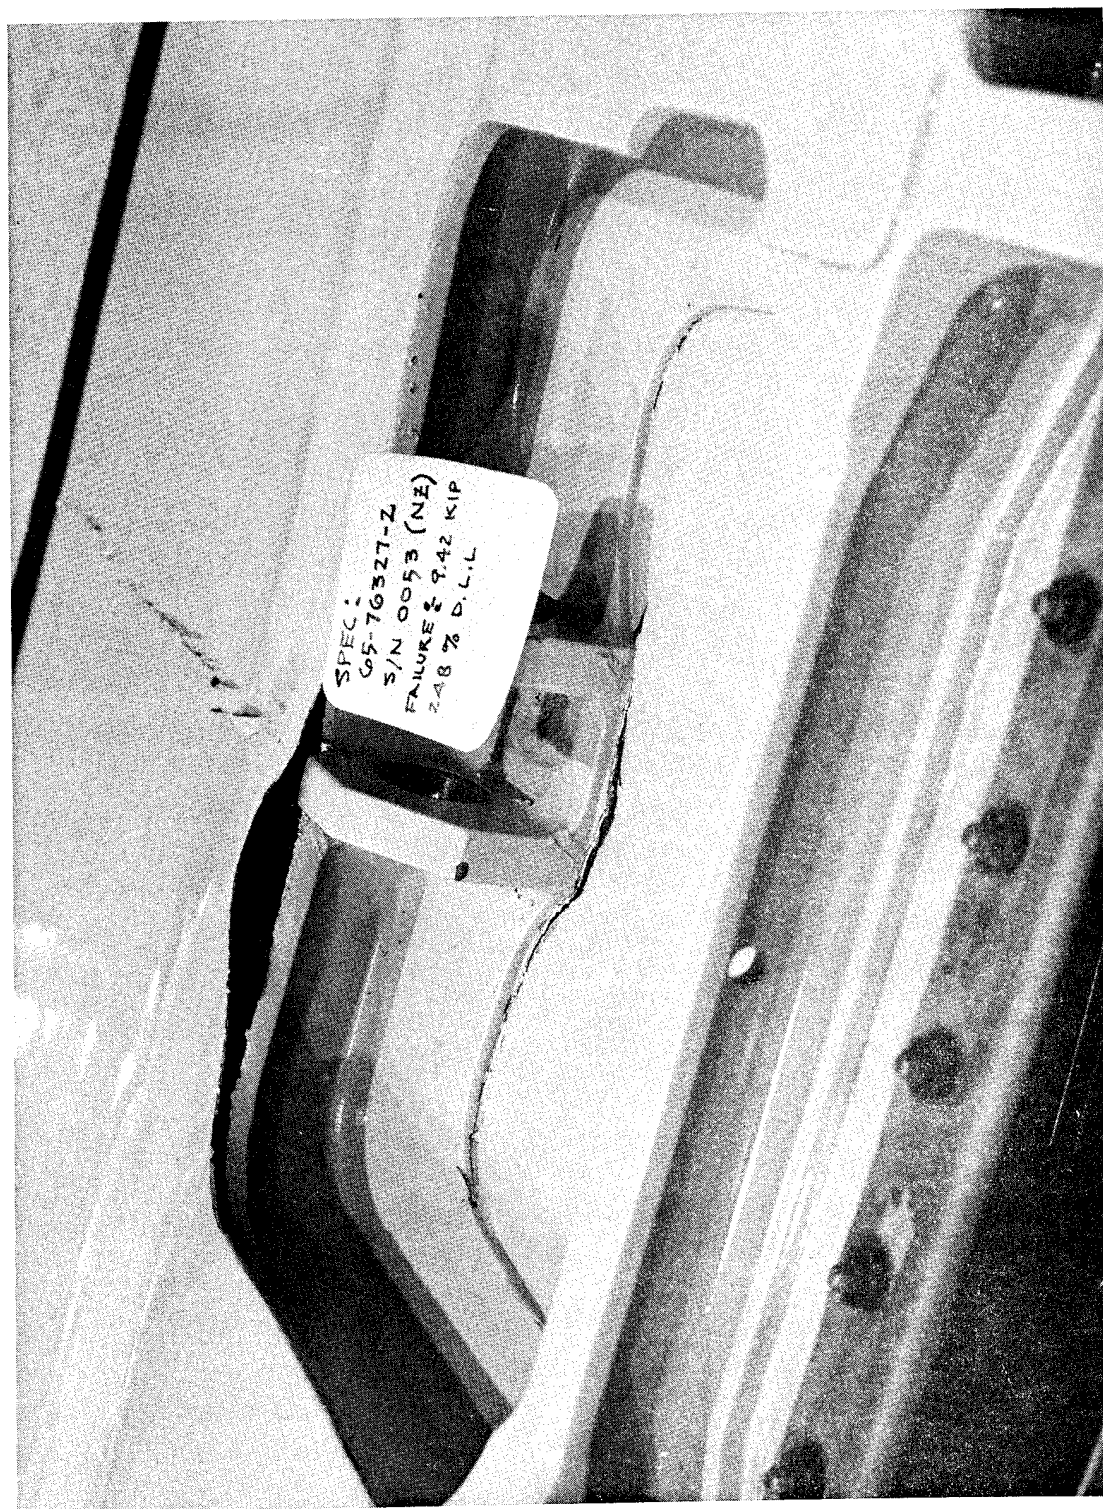
Figure 12.—Failure of S/N 0053 Above and Below Center Hinge Fitting

2. Failure mode of the T300/5209 spoiler (S/N 0053) has been assessed as a primary lower skin buckling immediately adjacent to the CHF. An additional failure of the -11 aluminum doubler under the upper skin precipitated the upper skin tension failure. Both failures were influenced by deflection of the CHF. Failure of the comparable certification test spoiler (S/N 0041) was attributed to upper surface skin tension failure precipitated by yielding and failure of the CHF.
